भारत का राजपत्र The Gazette of India

“मैसर्स सेन्ट्रल कोलफील्ड लिमिटेड की सेन्ट्रल सौंडा कोलियरी में घटित बड़ी दुर्घटना की, जिसमें 14 व्यक्तियों की मृत्यु हुई थी, के संबंध में जांच न्यायालय की रिपोर्ट।”

**15 जून, 2005 को मेसर्स सेन्द्रल कोलफिल्डस् लिमिटेड के
सेन्द्रल सौंडा कोलियरी में 14 व्यक्तियों के प्राणघातक
दुर्घटना के संबंध में जाँच अदालत का प्रतिवेदन**

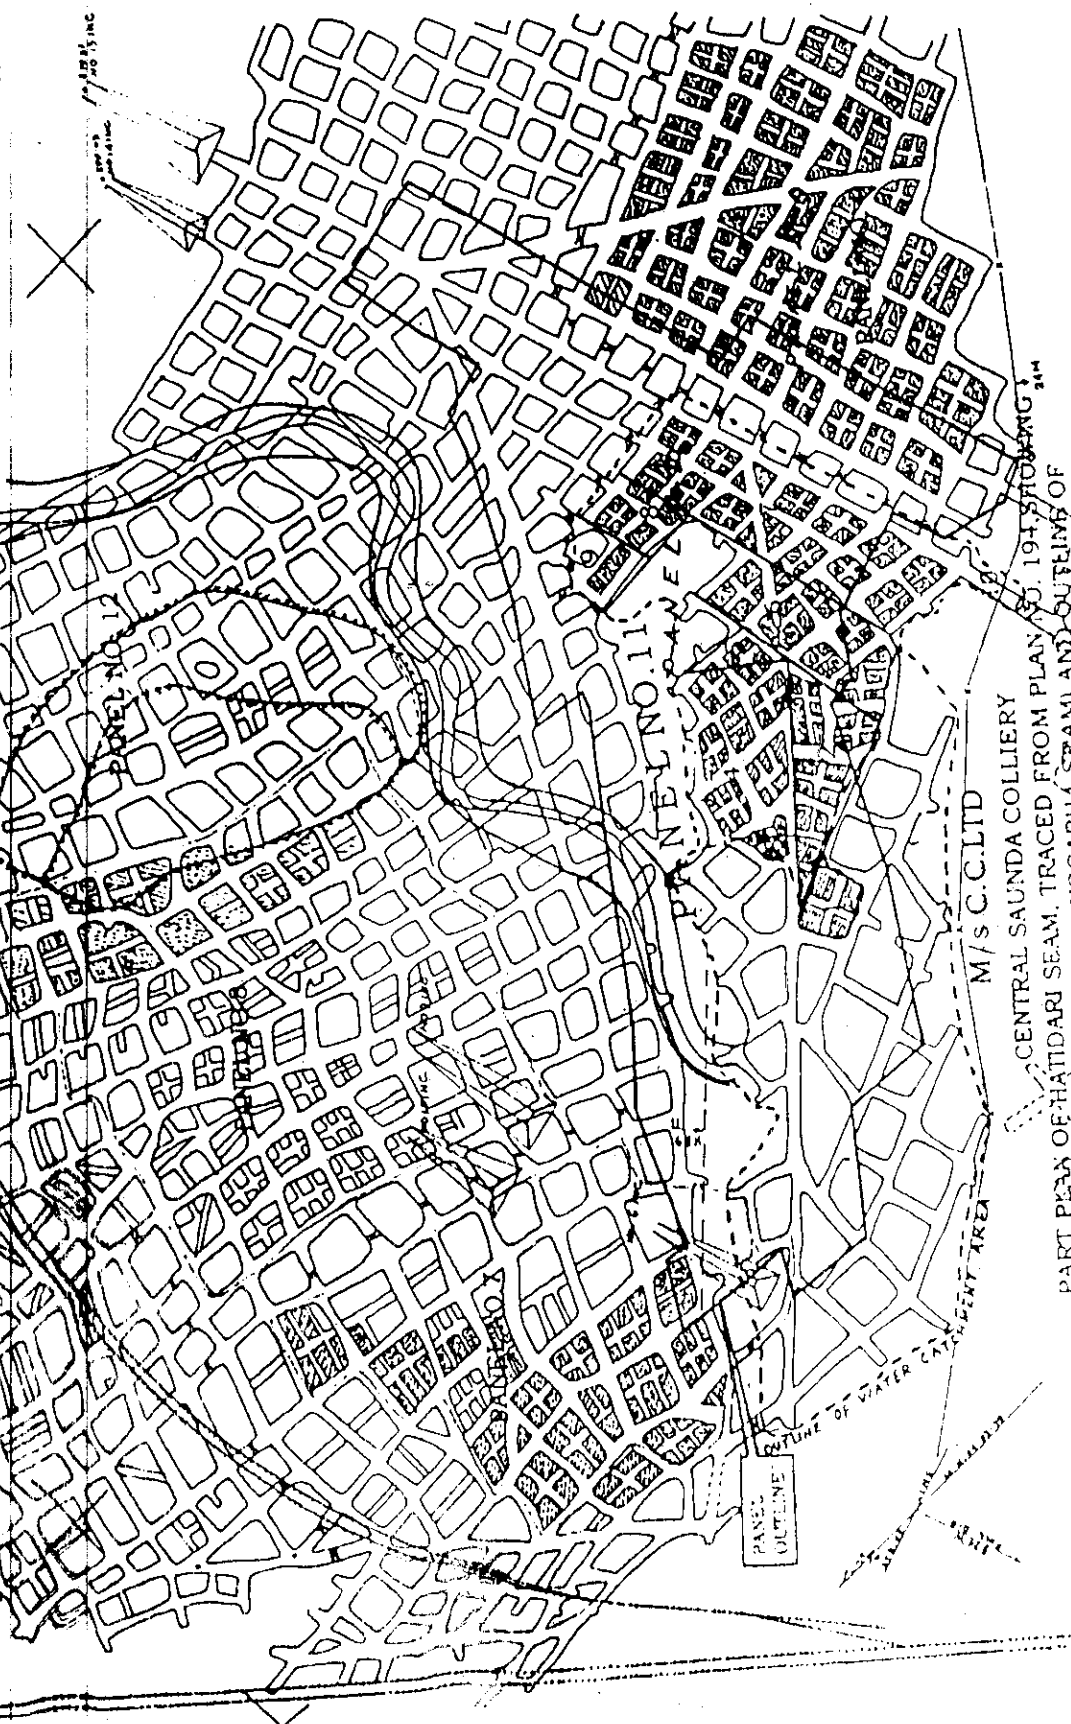
ANNEXURE - XI

CENTRAL SAUNDA COLLIERY
 PART PLAN OF HATIDARI SEAM, TRACED FROM PLAN NO. 194, STATIONING 344
 OUTLINE OF PANEL NO. 11 (BANSAGARHA SEAM) AND OUTLINE OF
 PROBABLE WATER CATCHMENT AREA. SCANNED AND REDUCED
 NOT TO SCALE.
